Manhole Inspection Summary

Manhole # S29GG1021MH

Insp Date: **1/4/07 8:53 AM**

Location Address: **3940 BEECH AVE**

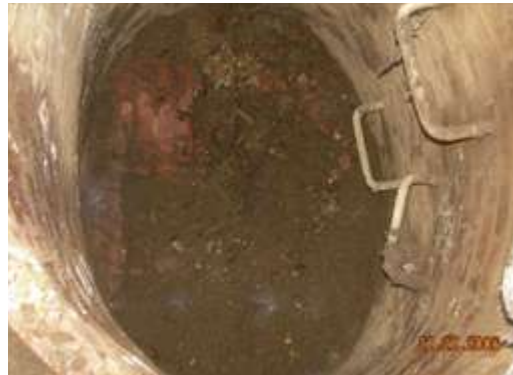
Top View

Channel debris.

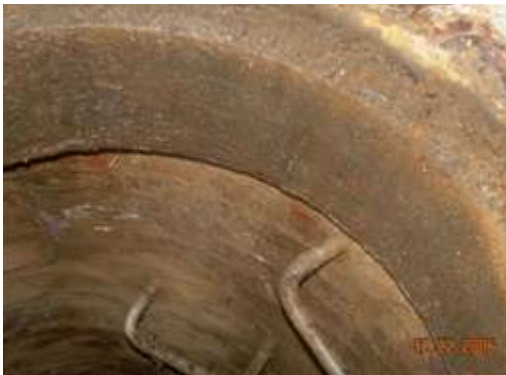
Defect

☒ **Leaks**

Infiltration: ☐ None ☒ **Joint** ☐ Cracks ☐ Mortar ☐ Roots ☐ Wall

Frame leaks. Corbel infiltration.

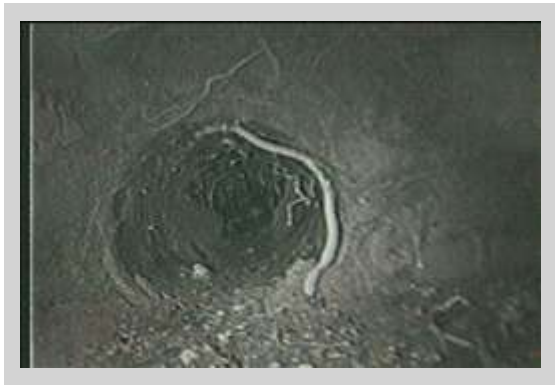
8 in. Circular Gravity Sewer
Pipe Out @ 12 O'Clock

Condition: ☐ Sound ☐ Cracked ☒ **Root Intrusion** ☐ Loose Brick ☐ Deteriorated

Infiltration: ☐ None ☐ Joint ☐ Cracks ☒ **Mortar** ☒ **Roots** ☒ **Wall**

Barrel root intrusion and infiltration.

Deposits: ☐ None ☒ **Mud** ☐ Sludge ☒ **Debris** ☐ Grease

Infiltration: **Evidence** Pipe Seal Cond: **Roots**
